Situation Photo Log

Monday, July 30, 2012

Weather / River Conditions for Friday July 27, 2012

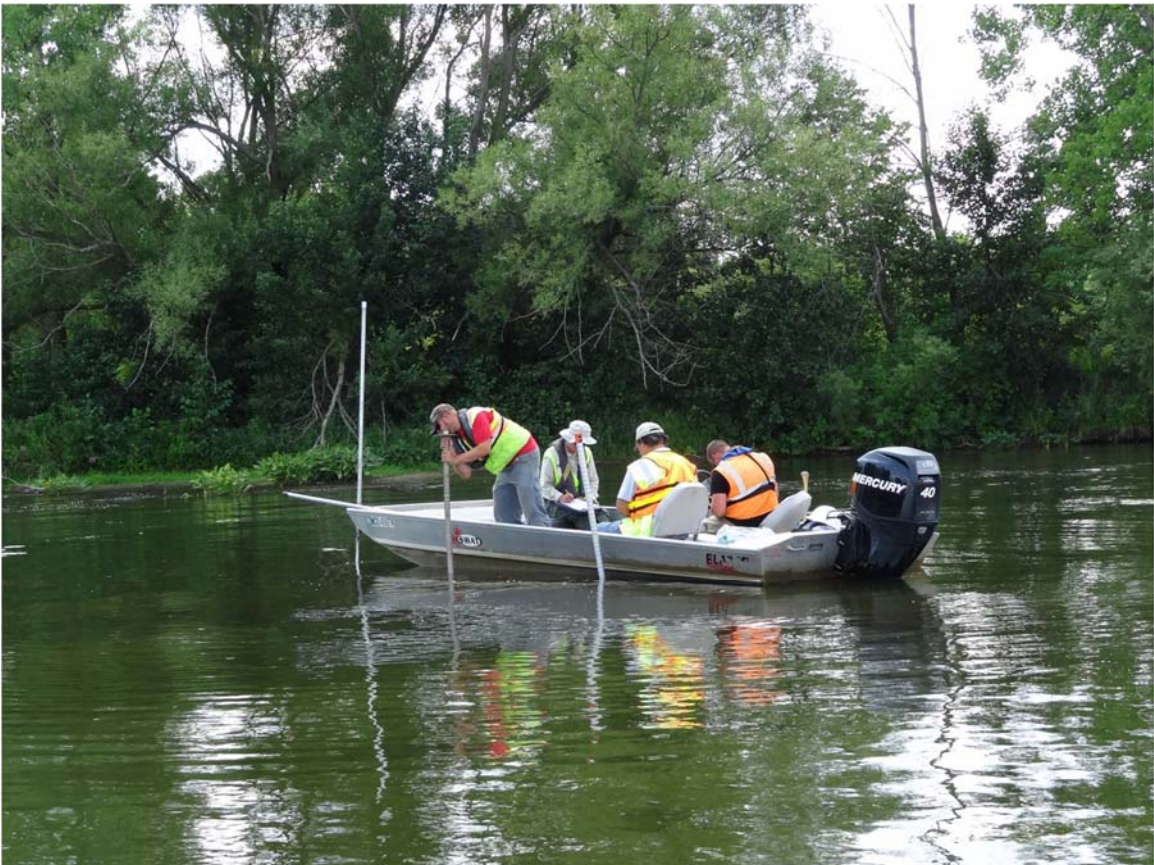
24. Morrow Lake observed the poling crew operating in the southwest end of the lake.

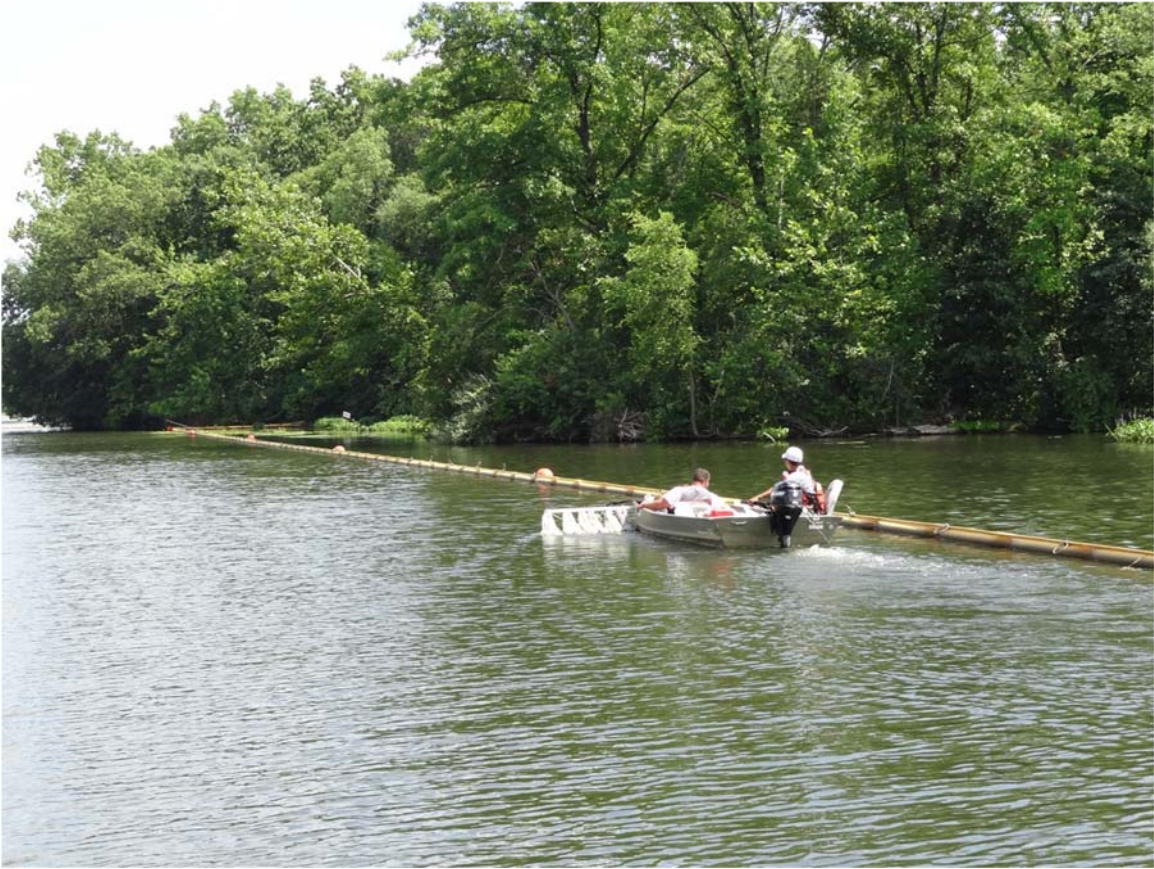
25. Morrow Lake Delta Boom E observed the sheen sweep boat operating.

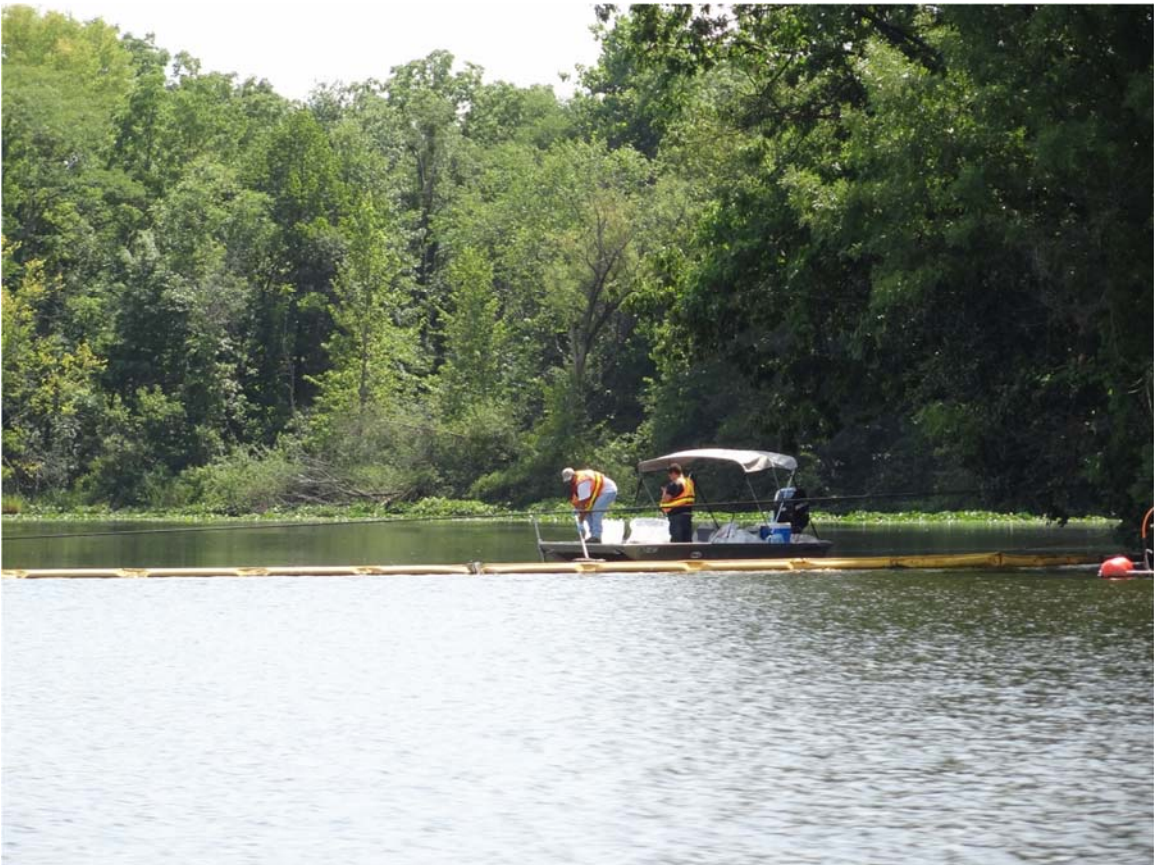
26. Morrow Lake Delta Boom C observed boom maintenance.

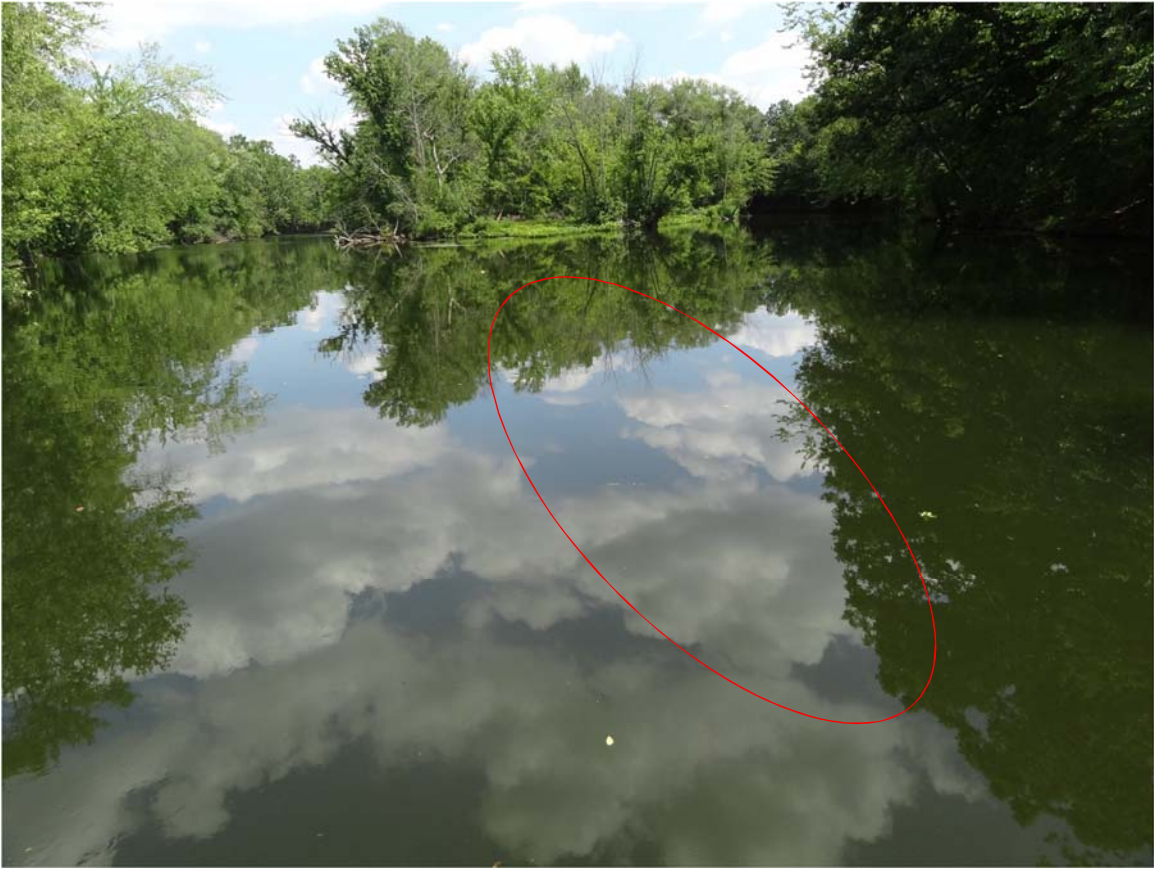
27. MP36.25 LDB observed sheen.

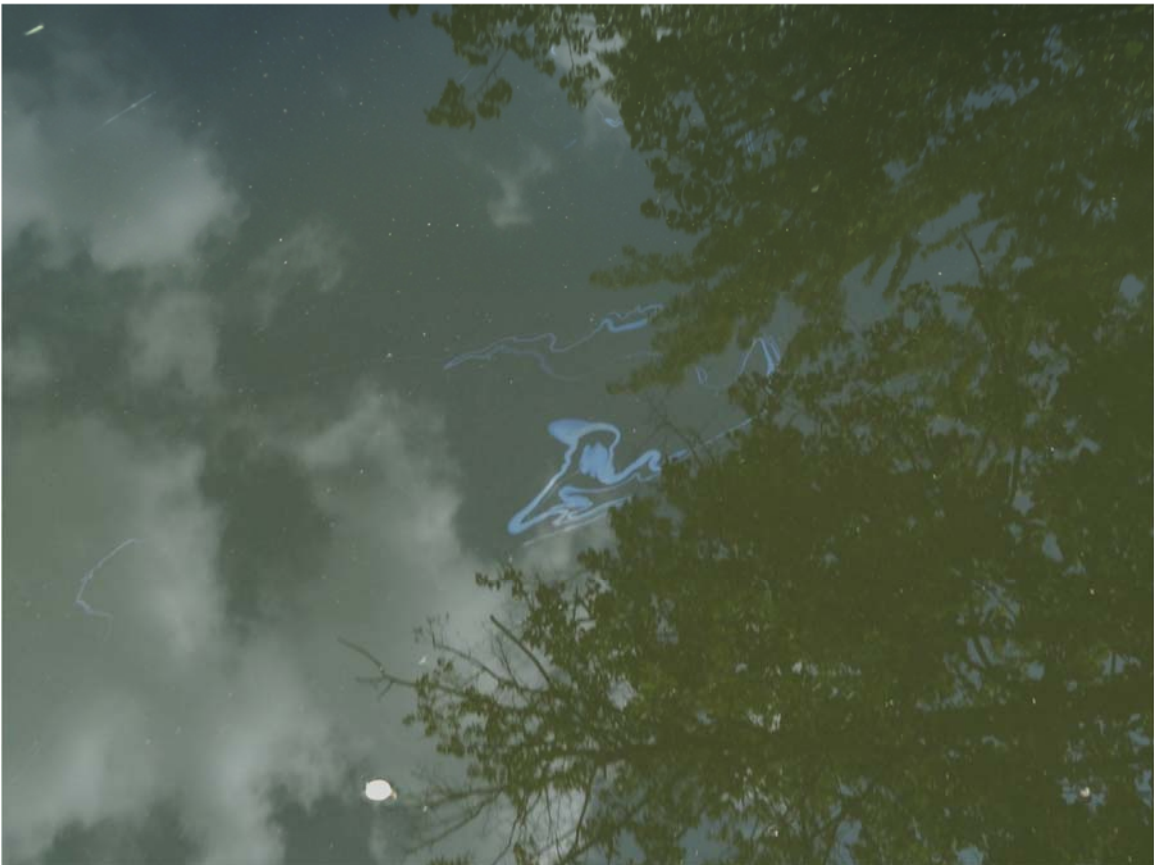
28. MP36.25 LDB observed sheen, did not require a sweep boat. However area is a reoccurring sheen location.
